TWO-STAGE POTASSIUM TEST TURBINE

Volume IV

Materials Support of Performance
and Endurance Tests

Prepared under Contract No. NAS 5-1143 by
GENERAL ELECTRIC
Cincinnati, Ohio

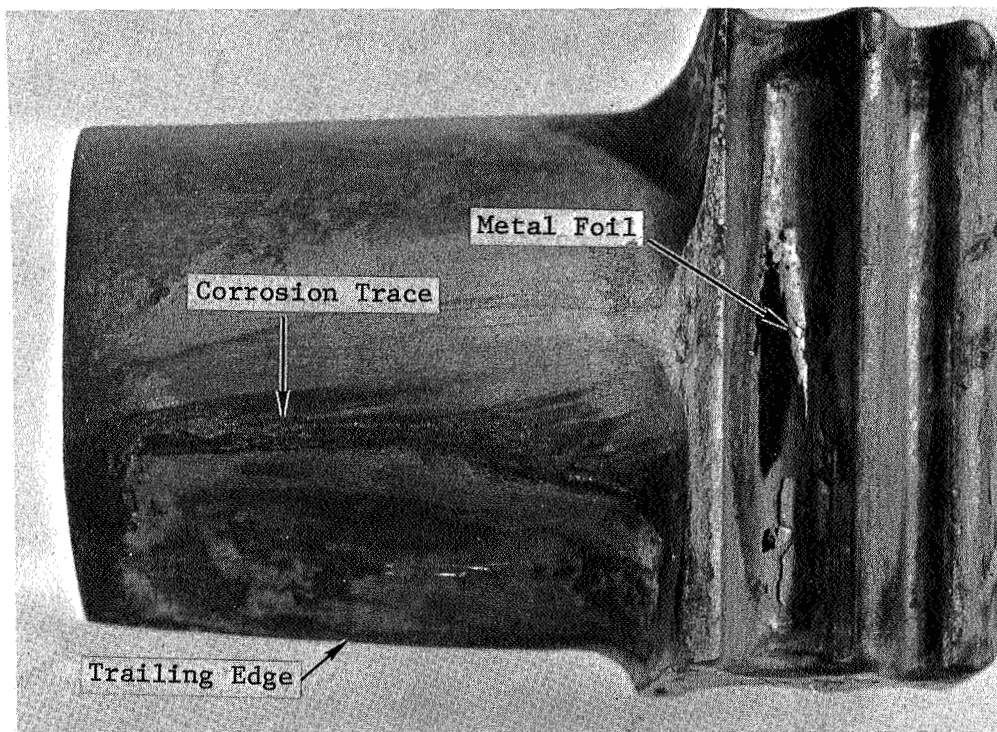
Turbine Blade Corrosion - The post-test appearance of the first stage U-700 turbine blades is shown in Figures 51 through 54 and that of the second

Figure 53. Convex Side of U-700 First Stage Turbine Blade After 2000-Hour Endurance Test. (C66011346) Mag: 5X

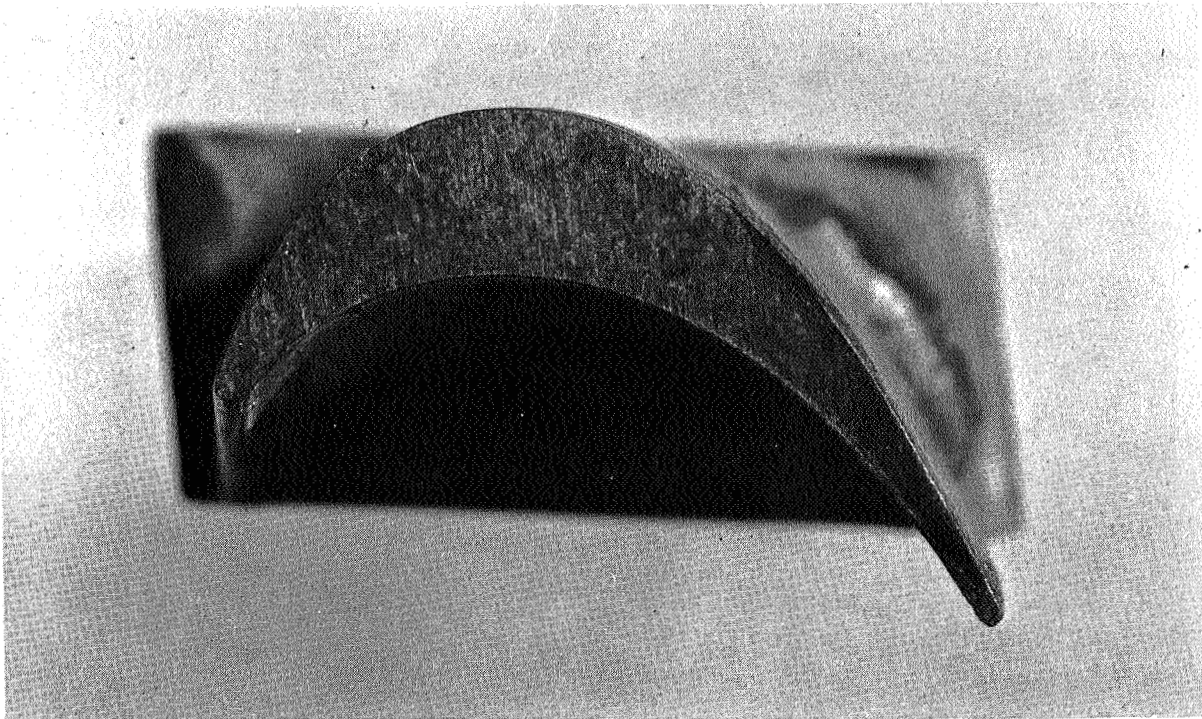
Figure 54. Tip of U-700 First Stage Turbine Blade After 2000 Hour
Endurance Test. (C66011338)

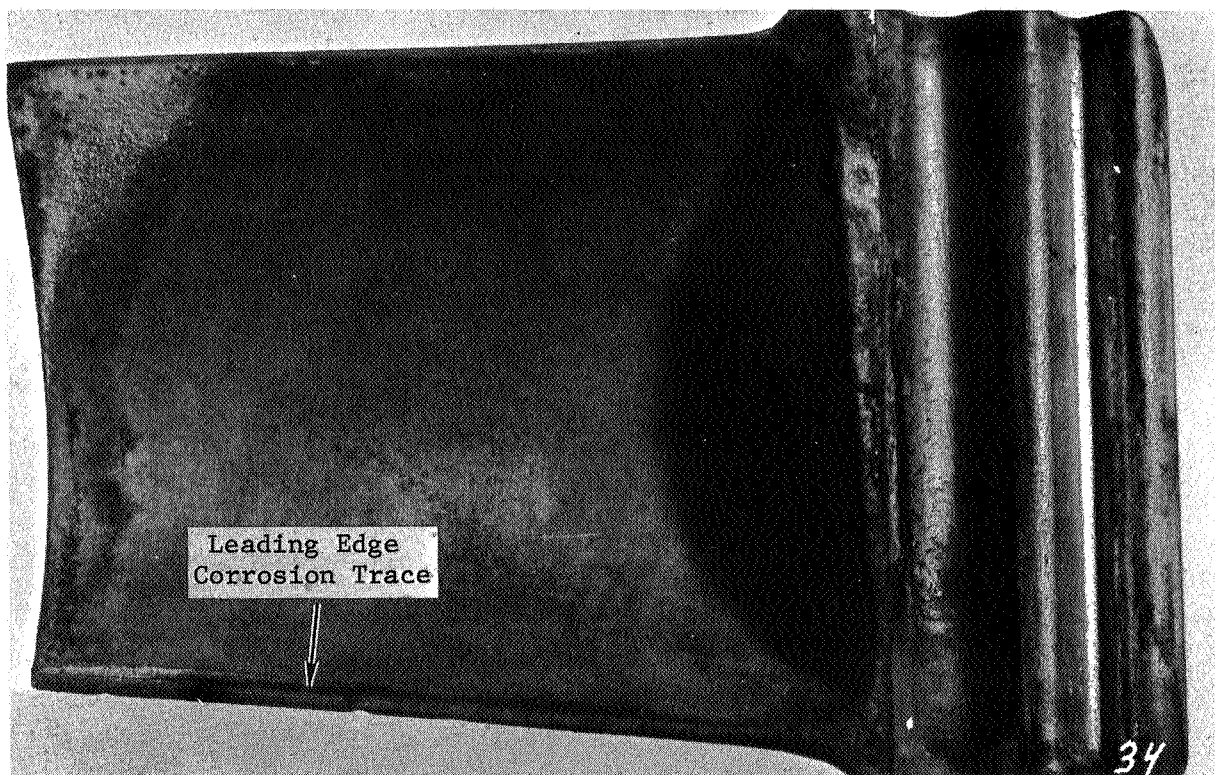
Figure 55. Concave Side of U-700 Second Stage Turbine Blade After
2000-Hour Endurance Test. (C66011345) Mag: 5X

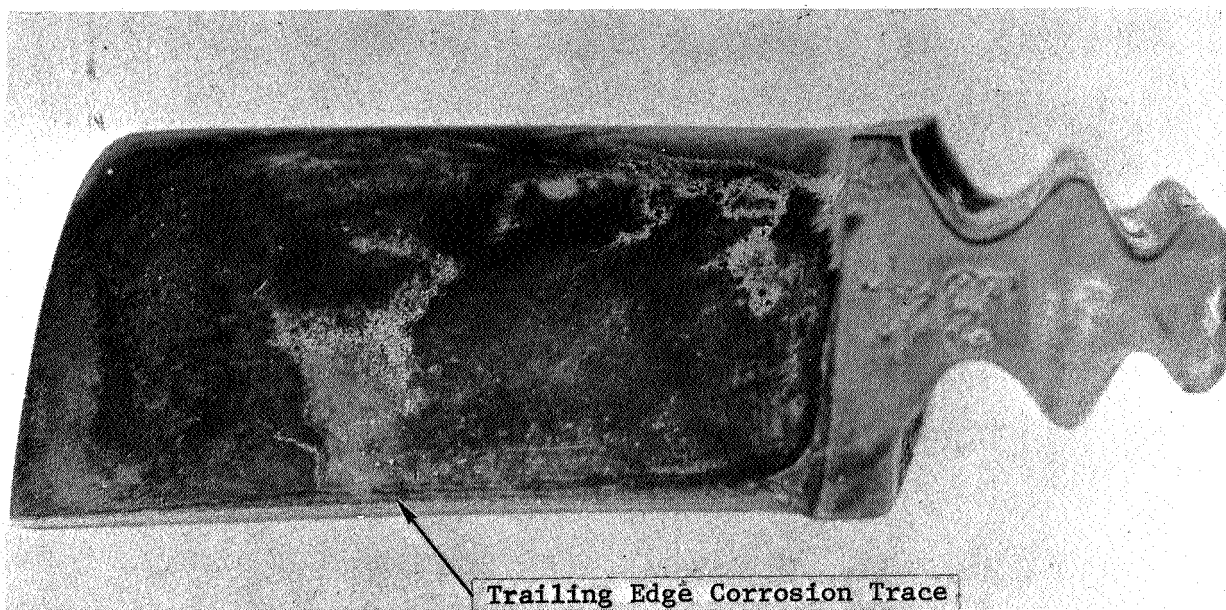
Figure 56. Trailing Edge of U-700 Second Stage Turbine Blade After
2000-Hour Endurance Test. (C66011341) Mag: 5X

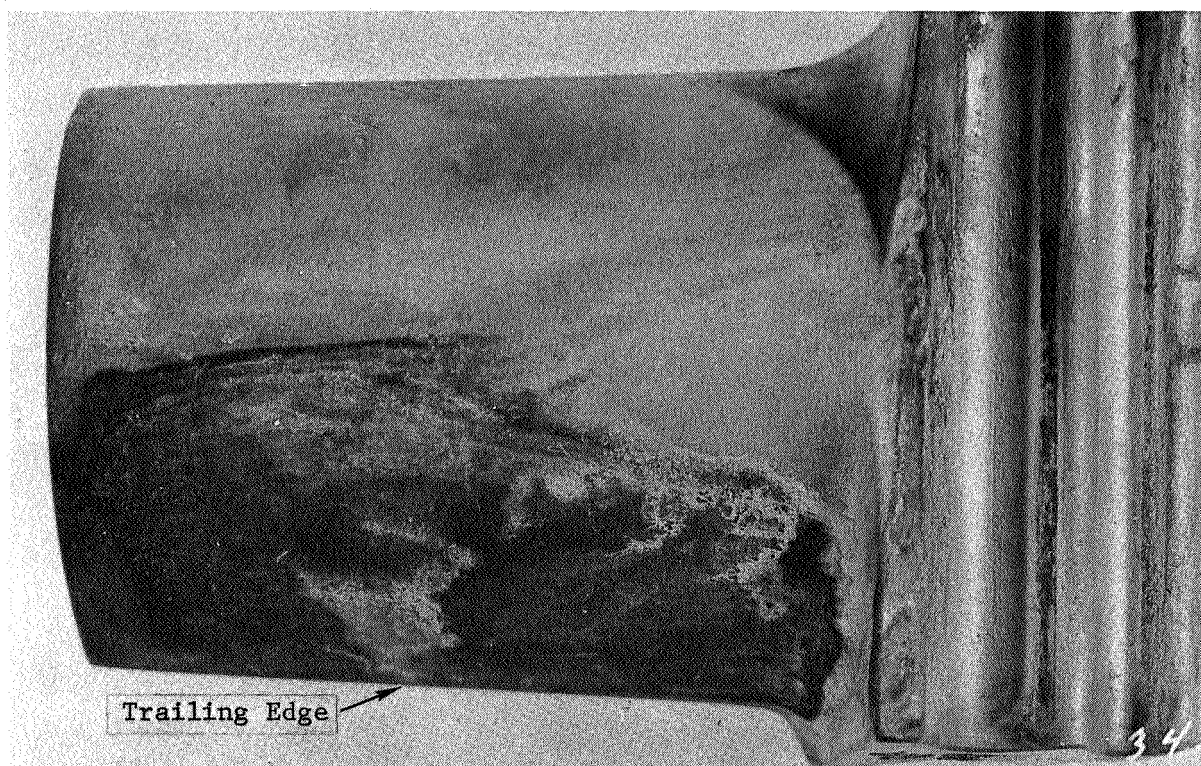
Figure 57. Convex Surface of U-700 Second Stage Turbine Blade After
2000-Hour Endurance Test. (C66011344) Mag: 5X

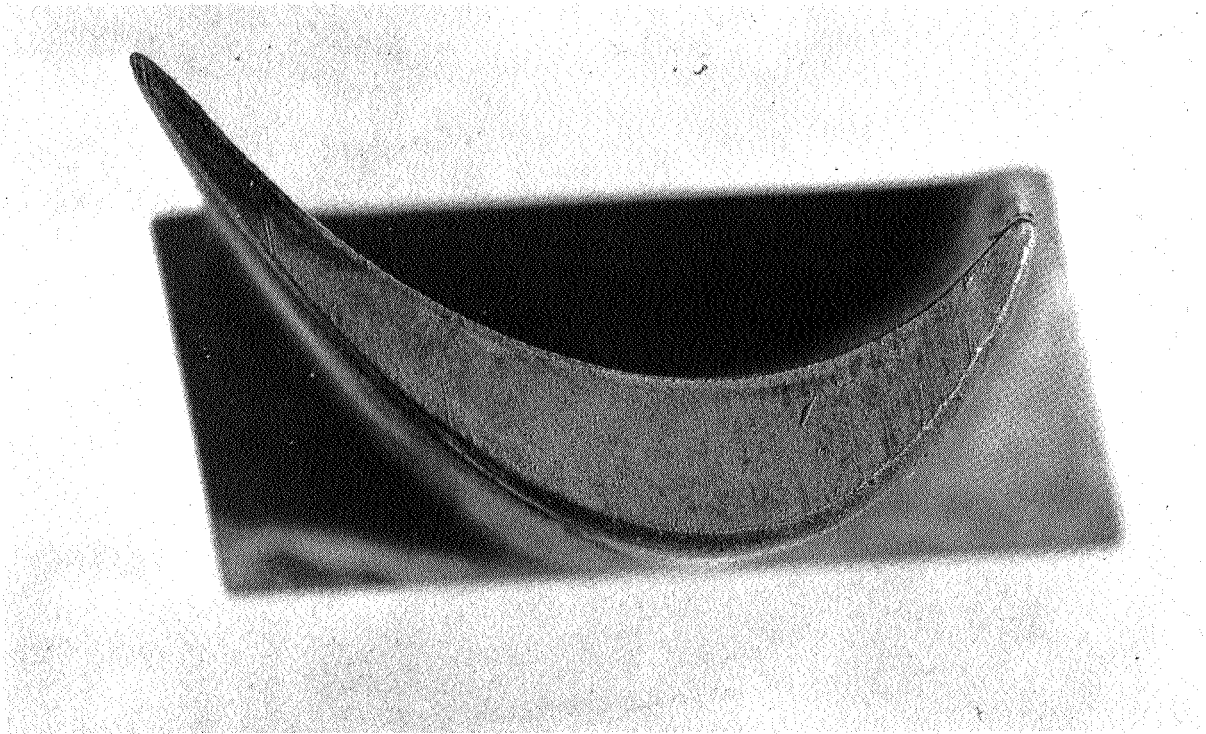
Figure 58. Tip of U-700 Second Stage Turbine Blade After 2000 Hour
Endurance Test. (C66011337)

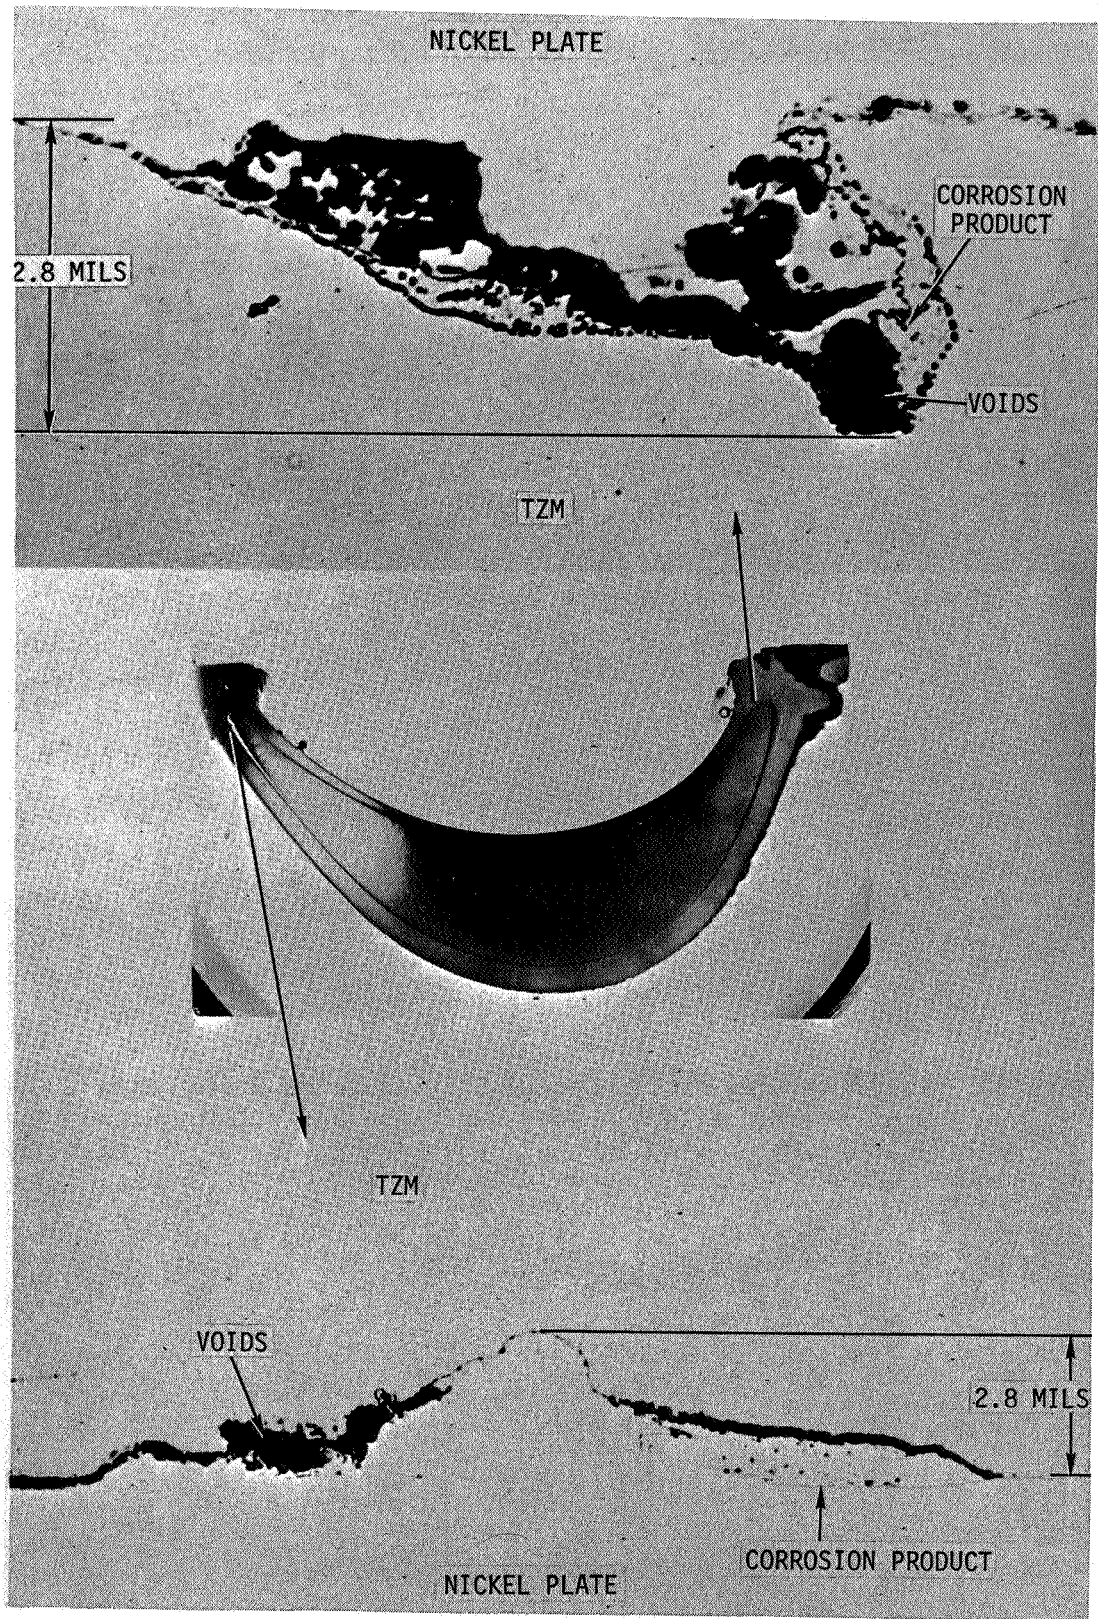
Figure 61. Leading and Trailing Edge Corrosion Traces and Micrographs of a Second Stage TZM Blade After 2000 Hour Endurance Test.

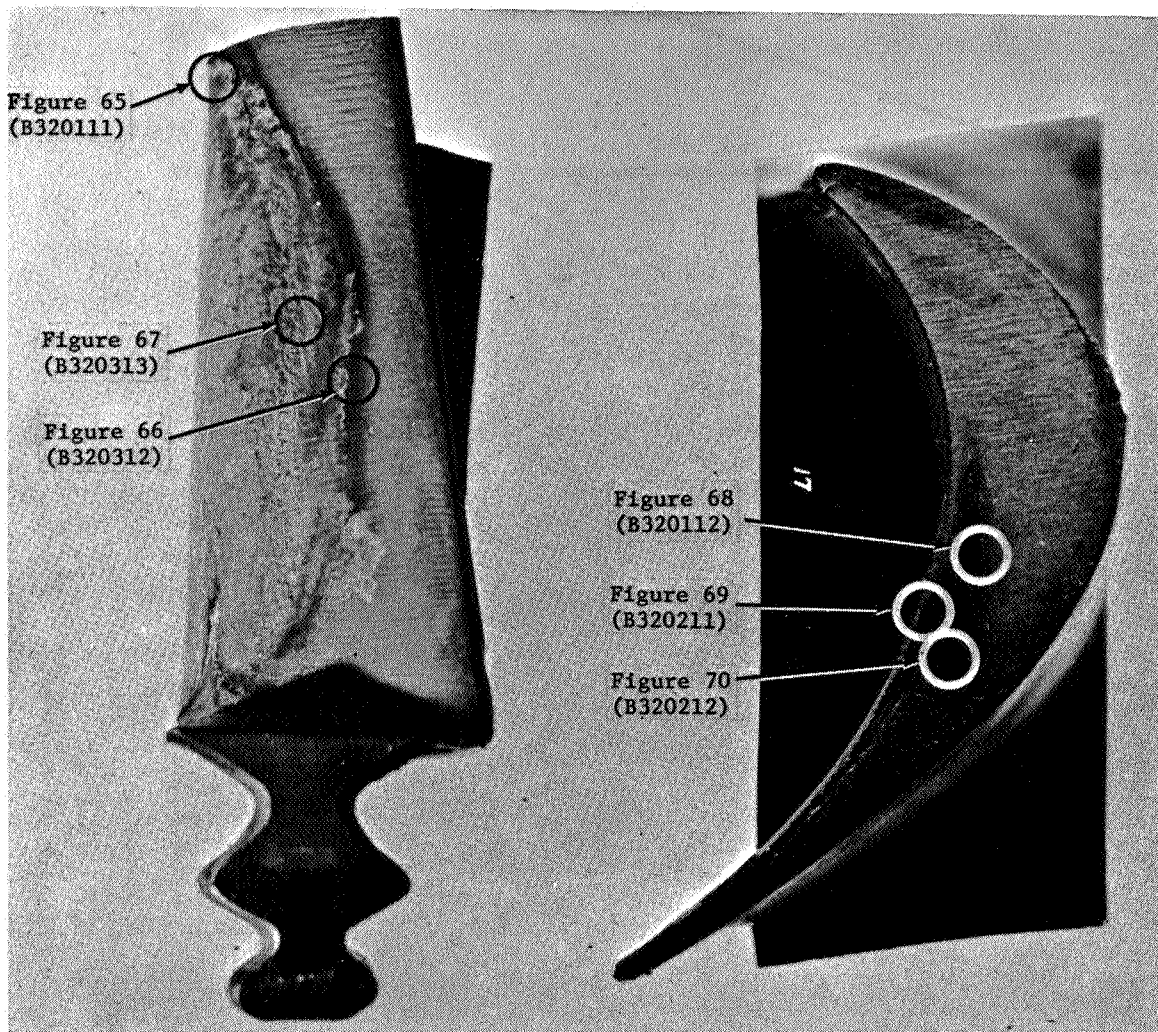
Figure 63. Location of Selected Micrographs Taken from the Convex Airfoil Surface and Tip of a TZM Second Stage Blade After 2000-Hour Test.

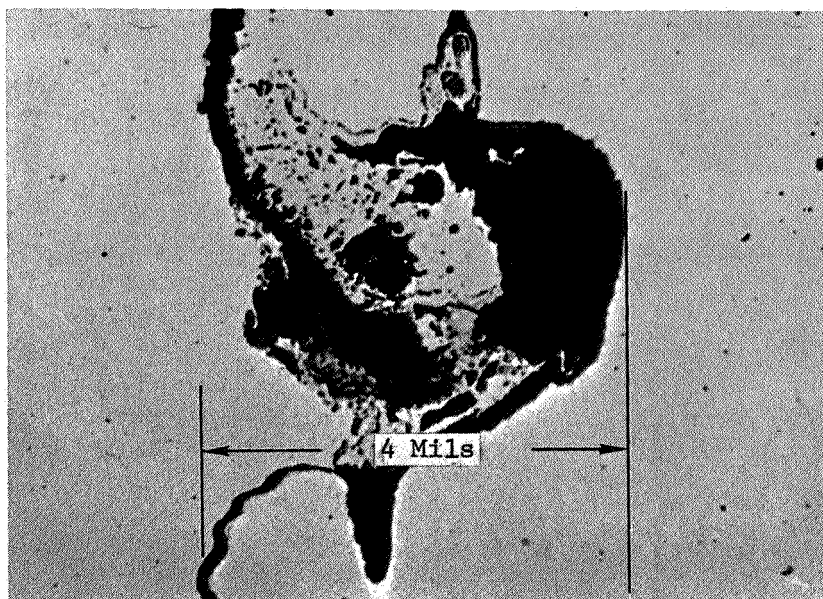
Figure 64. Convex Surface Near Tip of TZM Second Stage Blade After 2000 Hour Test. (B320111)

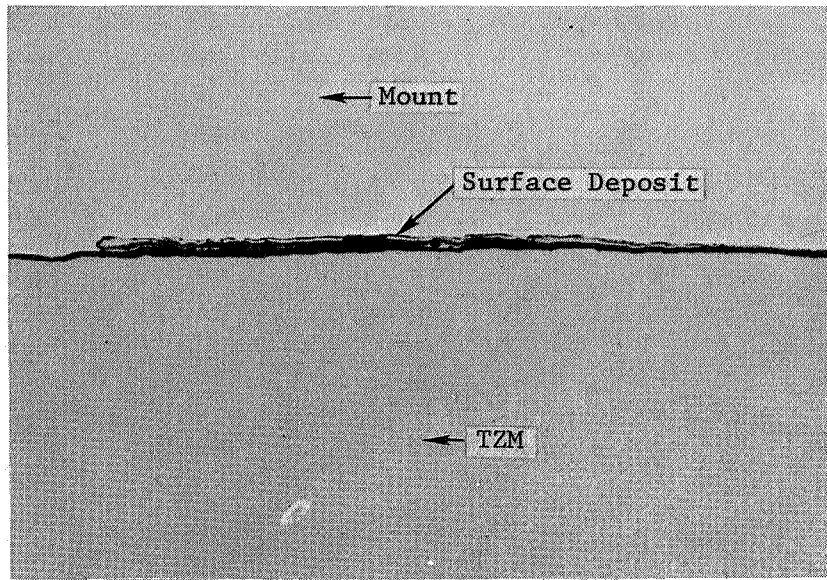
Figure 66. Convex Surface of TZM Second Stage Blade After 2000 Hour Test. (B320313)

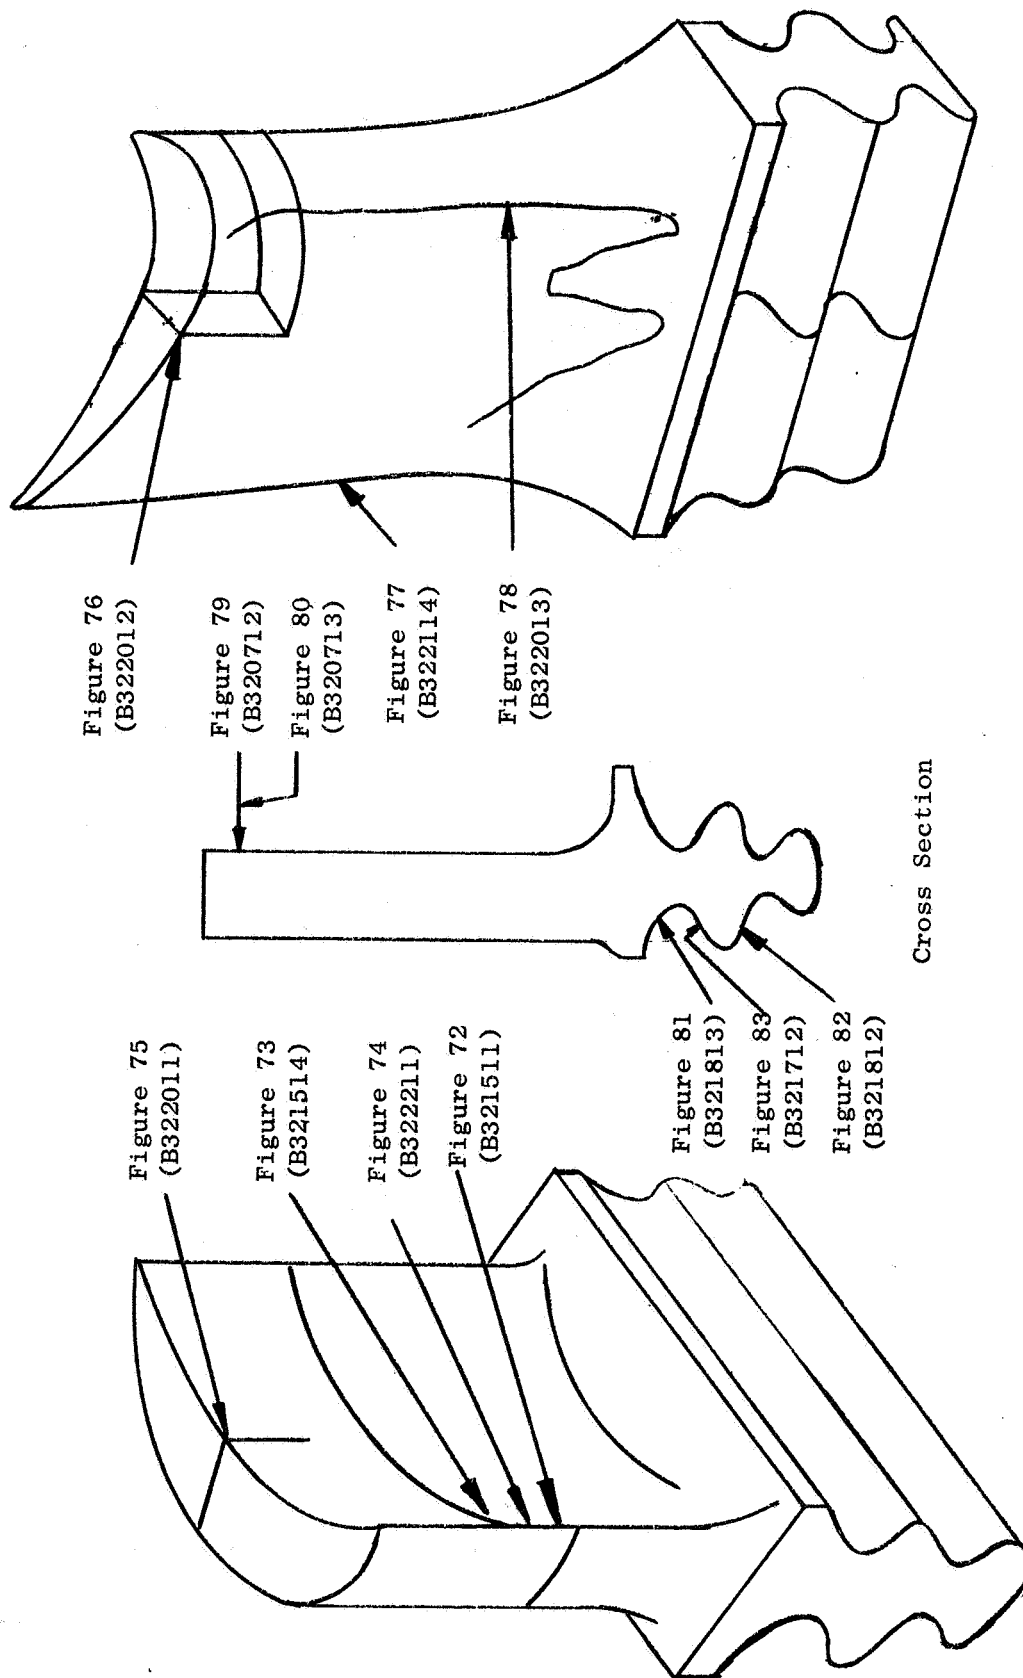
Figure 70. Location of Selected Micrographs of a U-700 First Stage Blade after 2000-Hour Endurance Test at Approximately 1450°F.

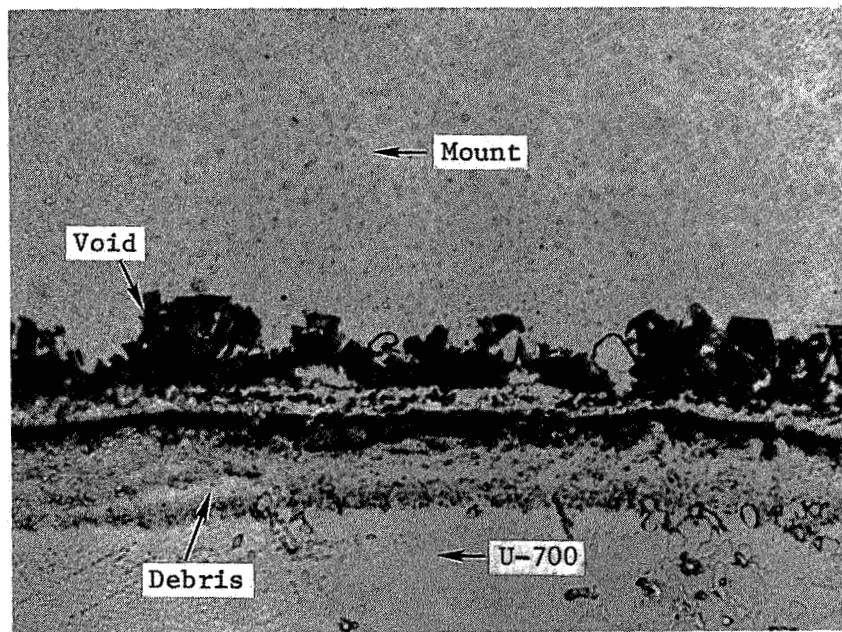
cavity. This formation was observed in several areas of the blade, through the depths measured generally less than 0.2 mil. Figure 73 shows a high magnification of the surface deposit on the concave surface at the leading edge. Figure 73 shows the light surface corrosion and metallic deposit at the concave tip.

Figure 73. Surface Deposit on the Concave Leading Edge of a First Stage Turbine Blade After 2000 Hour Endurance Test. (B322211)

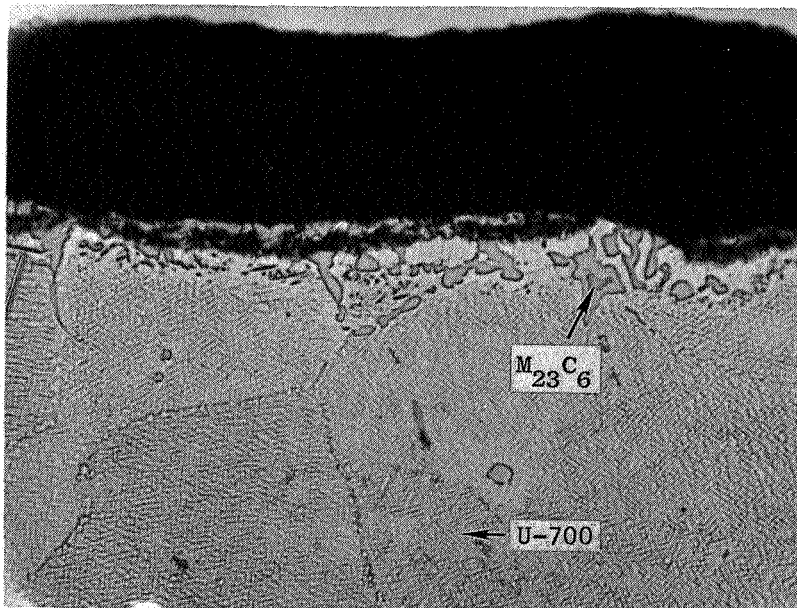
Figures 80 and 81 illustrate the extent of alloy depletion observed on the dovetail surfaces. The dovetail stresses, being considerably higher than the airfoil stresses, could have influenced the coalescence of the particles, probably $M_{23}C_6$ carbides, in the alloy depleted layer visible in dovetail photomicrographs. Figure 82 illustrates an area of the dovetail which had constant contact with the wheel; in this area, which had restricted contact with liquid potassium, no alloy depleted layer is present.

Figure 80. Alloy Depletion at Dovetail Surface of a First Stage U-700 Turbine Blade After 2000 Hour Test. (B321813)

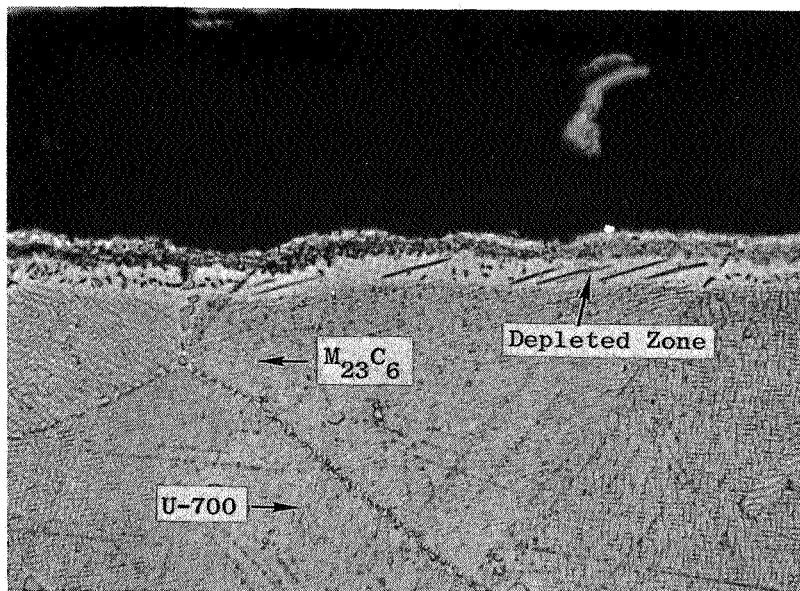
Figure 81. Alloy Depletion at Dovetail Surface of a First Stage U-700 Turbine Blade After 2000 Hour Test. (B321812)

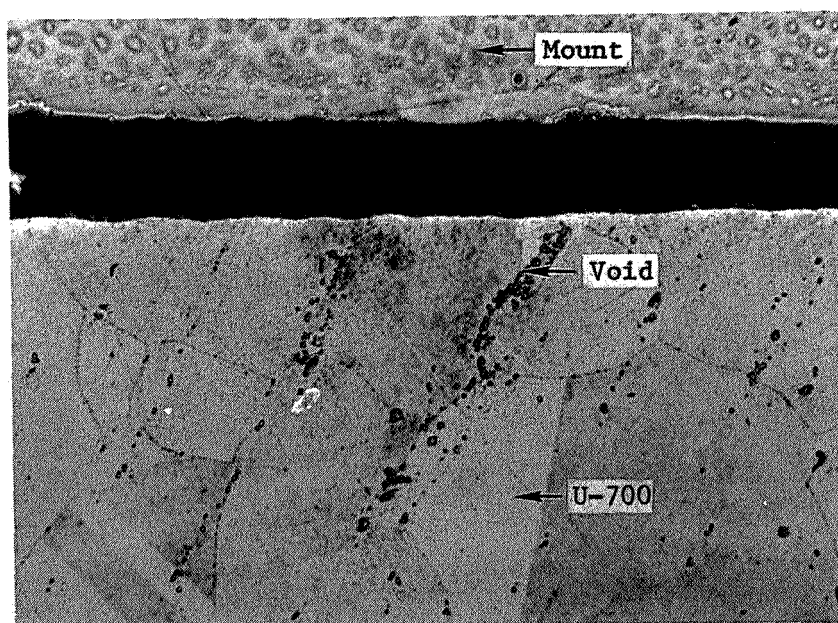
Figure 82. Dovetail Contact Area of a U-700 First Stage Turbine Blade After 2000 Hour Test. Note Lack of Depletion or Corrosion in Area Protected from Potassium. (B321712)

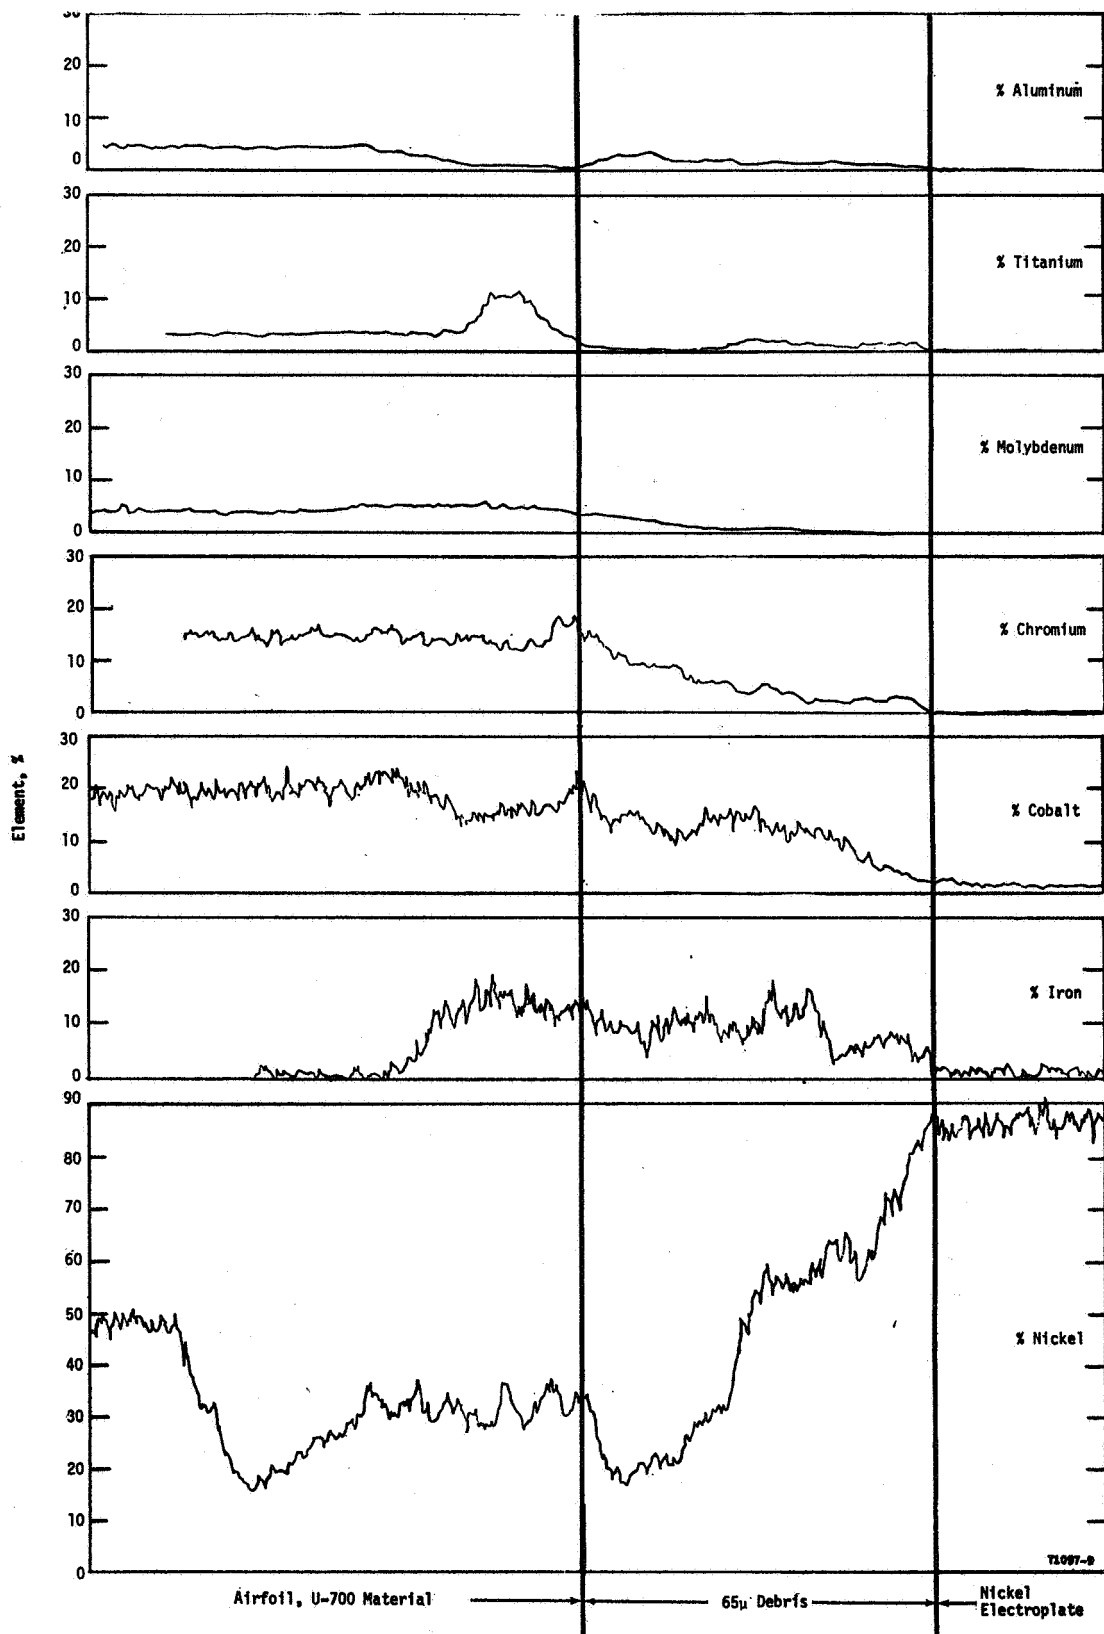
Electron Microprobe Evaluation - Electron microprobe traces were made across the cross section of a first stage U-700 turbine blade from the 2000-hour endurance test hardware. Nickel, iron, chromium, cobalt, molybdenum, titanium, and aluminum content were determined in the nickel electroplate, across the surface of the blade and to a depth of approximately 150 microns (.006 inches) below the surface of the blade. From the traces presented in Figure 83 it is evident that the elements molybdenum, chromium, and cobalt were gradually depleted in the base alloy to a depth of about 4 mils. The iron content was increased to a similar depth from an original value of 5 percent to an average of 15 percent, and the nickel in this same region was reduced from an original value of 50 percent to 20-30 percent. It is also evident that the titanium and aluminum content were altered near the surface. The surface debris was enriched in nickel and iron; it contained approximately 60-80 percent nickel and approximately 10 percent iron. That the surface debris was a deposit was confirmed by (1) its appearance in the photomicrographs, (2) the high iron content diffused into the U-700, and (3) the presence of a high nickel content layer over an area of U-700 which was depleted in nickel.

Figure 83. Electron Microprobe Traces of Surface Debris on First Stage U-700 Turbine Blade from the 2000-Hour Endurance Test.

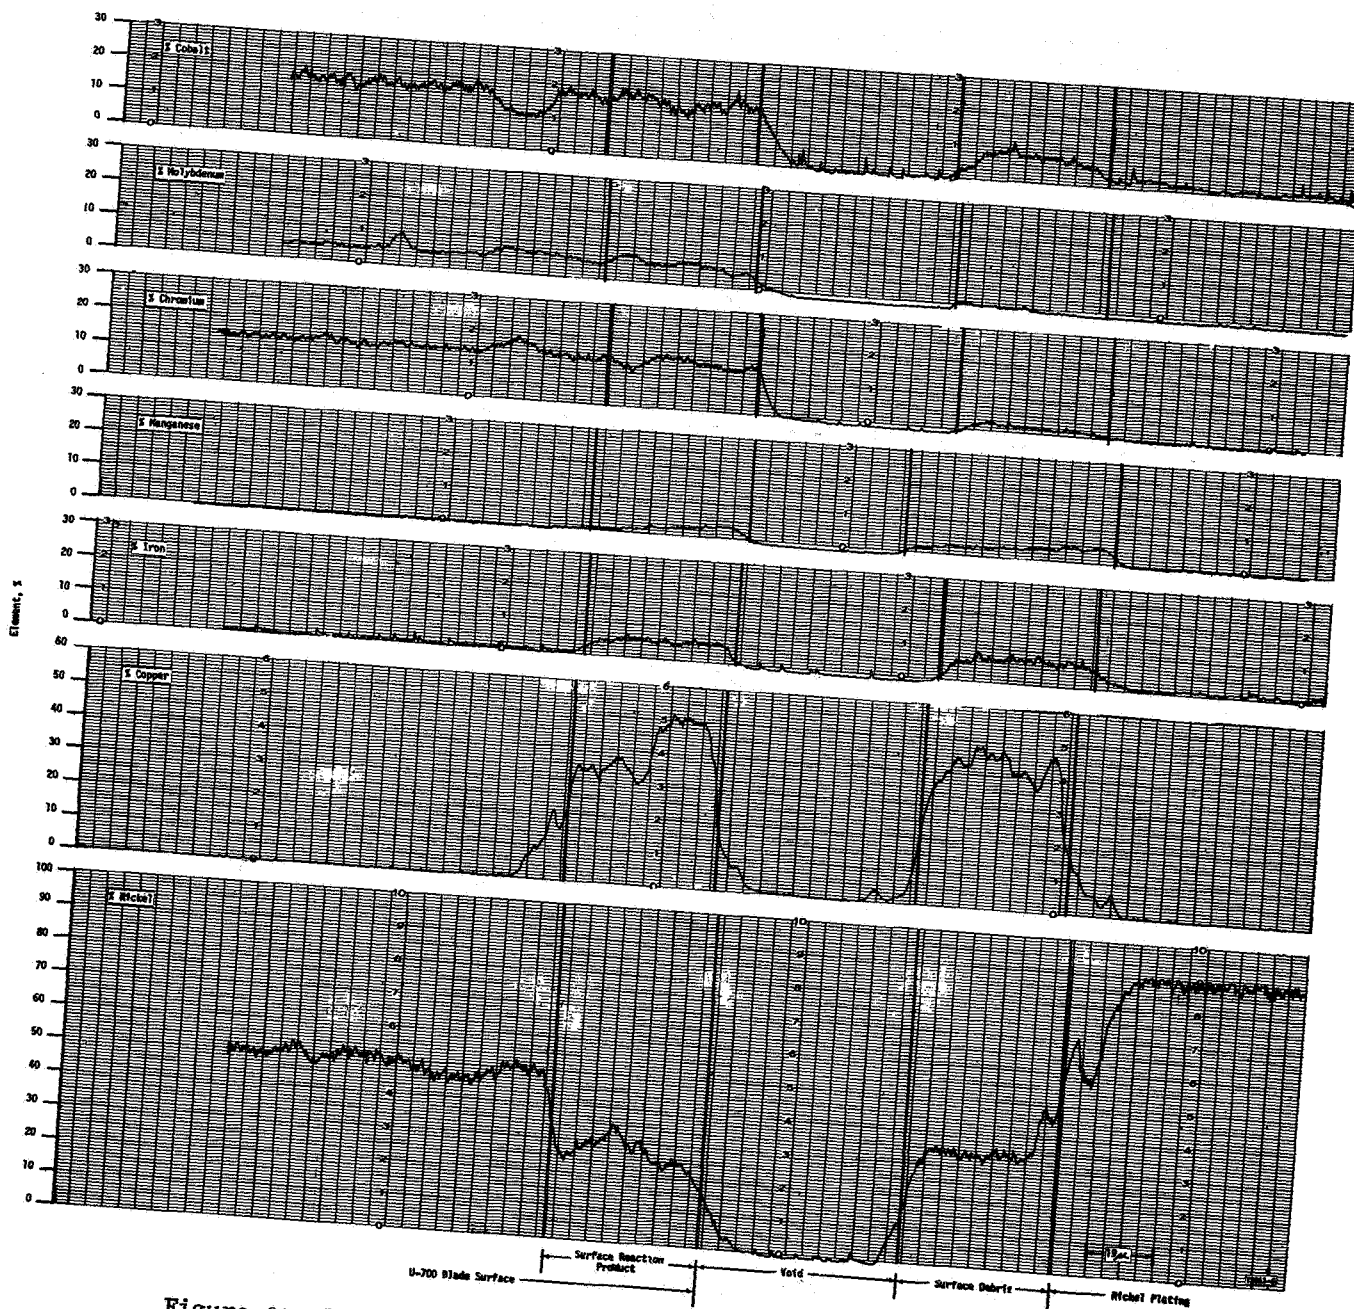
In addition to the above microprobe trace of a surface debris area, a microprobe trace was made of a surface reaction product observed at the convex airfoil surface immediately aft of the leading edge corrosion groove of a 2000-hour, first stage U-700 blade. This phase, which appeared pink when viewed with the optical microscope was found to contain the surprising amount of 40-50 percent copper to a depth of about 2 mils; an increase of 8-9 percent iron over the nominal base metal composition was also observed. The nickel content was found to have dropped to approximately 25 percent from the normal 50 percent alloy content. The electron microprobe traces of this pink phase are presented in Figure 84; in general, study of the other traces indicate that no change occurred in the molybdenum, aluminum, titanium, chromium and cobalt within this phase as compared to the base metal; however, the characteristic compositions of the surface debris were similar in both the above microprobe traces with respect to the base composition.

Figure 84. Electron Microprobe Traces of Surface Reaction Product and Overlaying Debris of First Stage Blade from 2000-Hour Test.

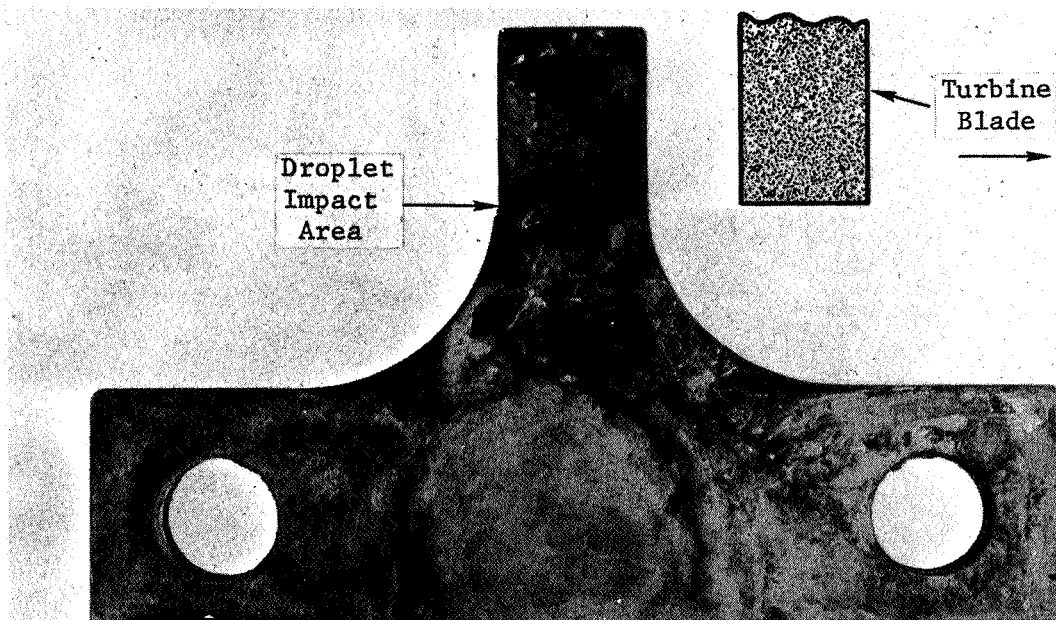
Binocular examination of the inserts after 2000 hours of testing disclosed minor, non-uniform surface deposits and discoloration. These deposits are found to consist of corrosion products and mass transported material similar to that observed on the endurance test blades. Figure 87 shows a typical example of the light surface corrosion and discoloration found on the erosion inserts.

Figure 87. Erosion Insert Showing Typical Discoloration.
(C66012437) Mag: 4X

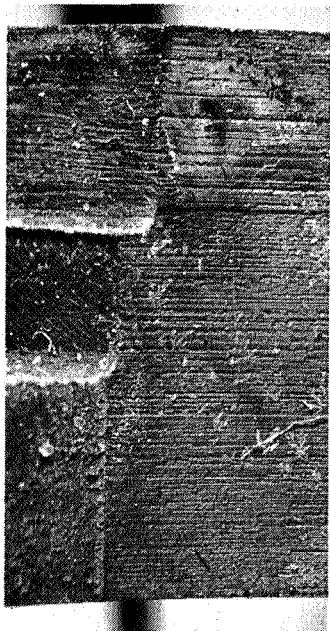
Figure 89. Liquid Potassium Impact Surface of Recrystallized TZM Erosion Insert Specimen Number B-2. Mag: 9X (C66012761)

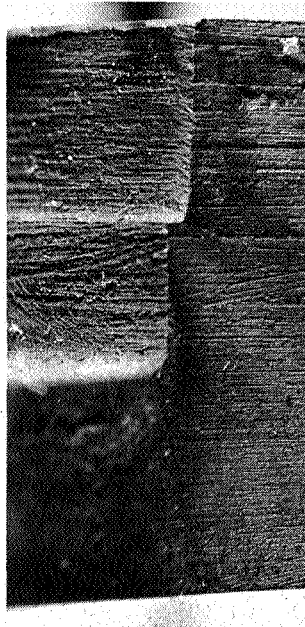
Figure 90. Liquid Potassium Impact Surface of Stress Relieved TZM Erosion Insert Specimen Number C-1. (C66012763) Mag: 9X

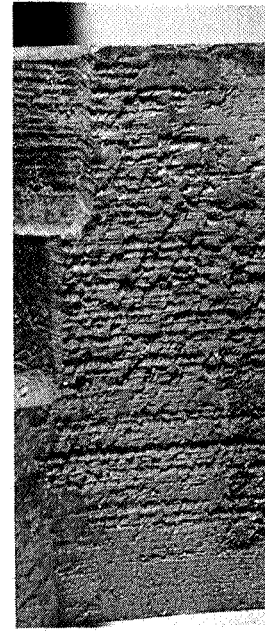
All of the erosion inserts were examined macroscopically before and after surface vapor blasting at magnifications as high as 60X for evidence of erosion. Macrophotos of these are shown in Figures 88 and 91.

Figure 91. Liquid Potassium Impact Surface of As-Received * TZC Erosion Insert Specimen Number D-2. (C66012757) Mag: 9X

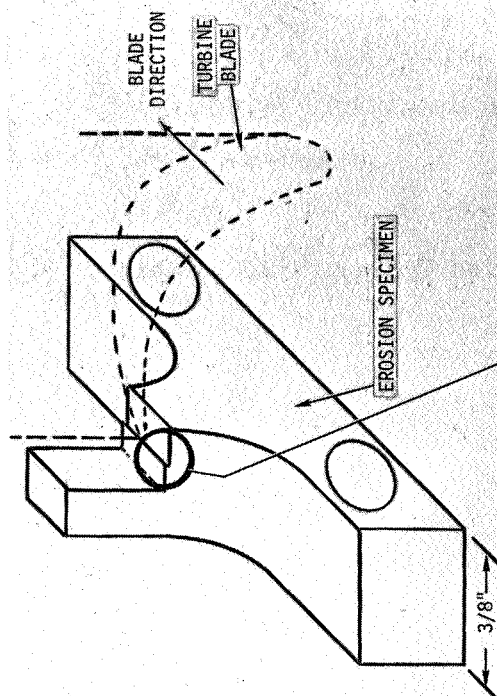
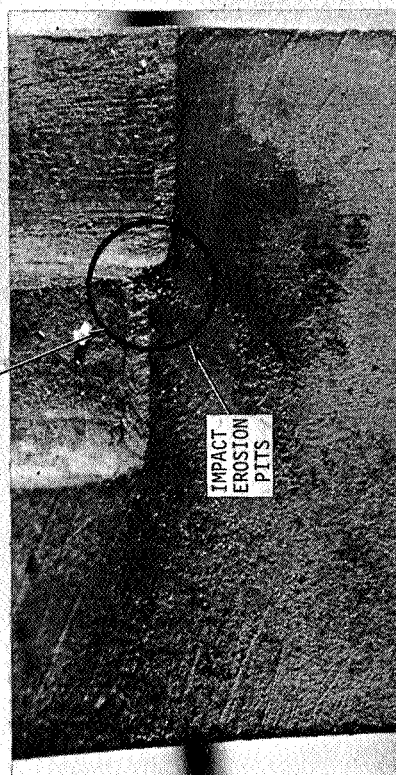
of the second stage blades as seen in Figure 88. These holes in the U-700 erosion inserts were examined metallographically at several planes through the impact erosion area. The holes were found to have a depth-to-diameter ratio of approximately 3 to 5 for the deeper holes. The interior surfaces of the holes were crazed with very small cracks penetrating inward approximately 0.0005-inch in some areas. Photomicrographs of the impact erosion area of U-700 erosion insert number A-3 are presented in Figures 92 through 96. Alloy depletion similar to that observed on the U-700 blades was observed on the U-700 erosion insert as seen in Figures 96 and 97; this surface effect was apparently unrelated to liquid impact as it was present on all exposed surfaces of the insert; this implied that a thin corrosive liquid potassium film was present over the entire insert surface.

These erosion inserts gave the first evidence of what could be classical liquid droplet impact erosion in the U-700 specimens and similar in nature to steam turbine erosion as seen earlier in macro form in Figure 43, and at larger magnification in Figure 98. The deep holes formed in the exact area where droplets would have been released from the second stage trailing edge blade tips and would have impacted on the erosion insert. The micro-cracks at the base of the holes are indicative of the impact erosion or cavitation erosion methods or mechanical damage. The surface areas between adjacent holes deteriorated either by an apparent randomness in the location of impacting droplets or by disruption of the surface between adjacent holes. At the periphery of the cluster of holes there existed occasional deep holes, with depths 4 to 5 times that of their diameters; these holes had formed in the original surface of the U-700 insert without doing damage to the adjacent surface. This type of erosion was similar to that reported by Hays⁸ for ductile materials in steam turbine erosion. In other examples of erosion, pits in otherwise unaffected surfaces have been noted in multiple droplet impact specimens and in cavitation damaged specimens. In water droplet impact in Stellite 6B erosion shields in steam turbines, deep pits or irregular cross section have been observed with depths of one to two diameters in areas where no adjacent surface damage was noted.

Figure 88. Liquid Potassium Impact Surface of U-700 Erosion Insert Specimen Number A-1. Note Impact Erosion at Upper Center. Mag: 9X

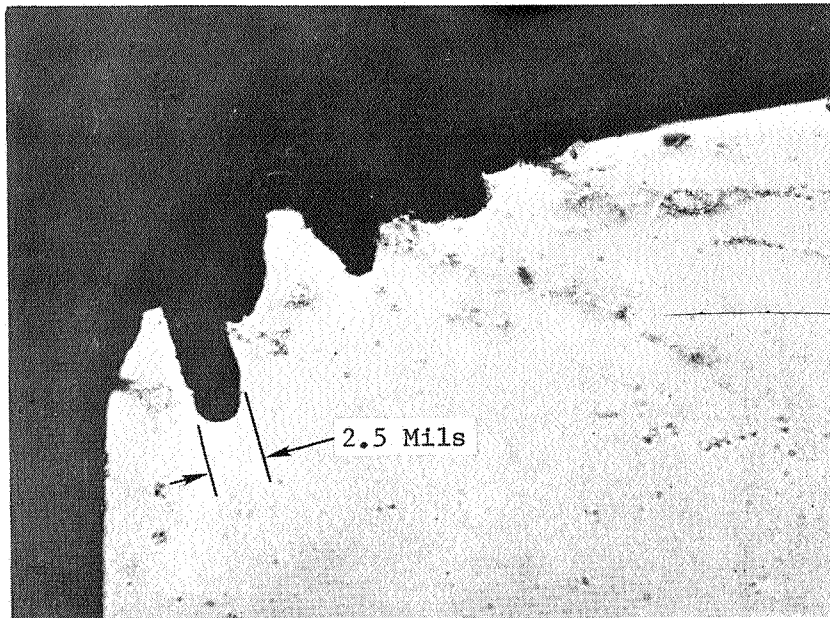
Figure 92. Impact Erosion Pits in U-700 Erosion Insert A-3. (B340111)
Etchant: Unetched Mag: 100X

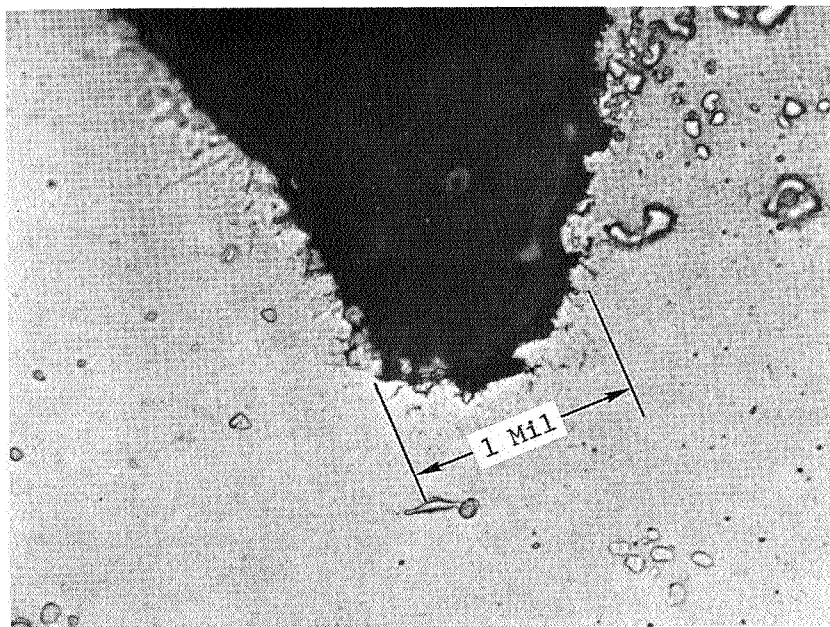
Figure 93. Impact Erosion Pits in U-700 Erosion Insert A-3 (Center Pit
in Above Figure). (B340112)
Etchant: Unetched Mag: 1000X

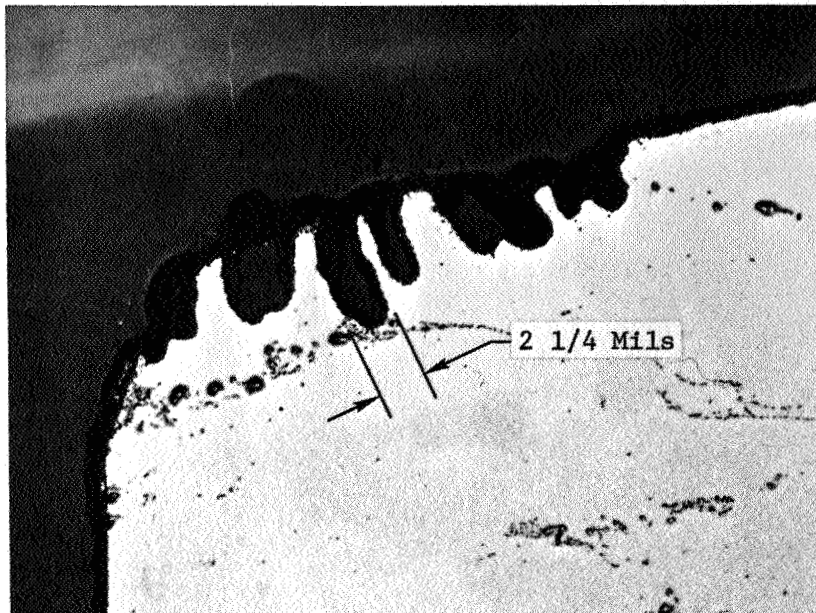
Figure 94. Impact Erosion Pits in U-700 Insert A-3 at a Third Planar Position. (B340117)

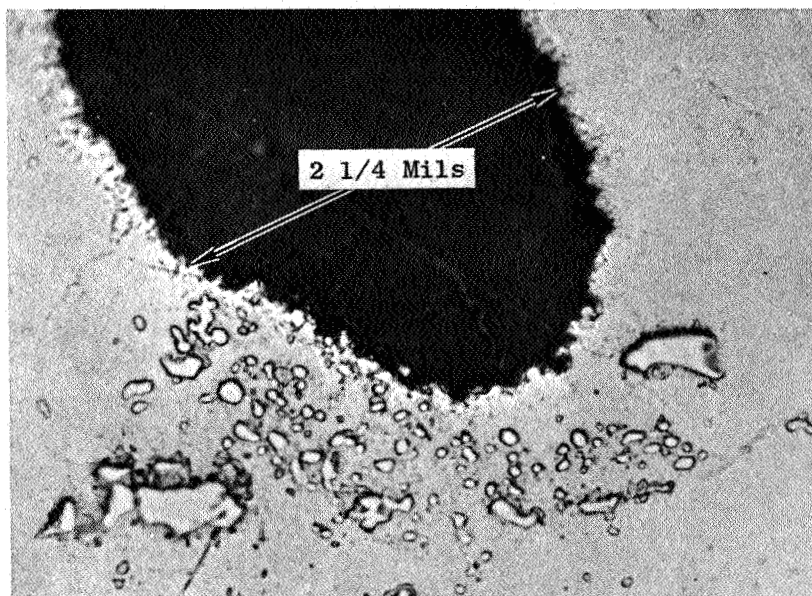
Figure 95. Impact Erosion Pit in U-700 Erosion Insert A-3. (Deepest Pit in Above Figure). (B340116)
